AFFDL-TR-66-76

THERMANTIC STRUCTURE TEST PROGRAM

TECHNICAL REPORT AFFDL-TR-66-76

ABSTRACT

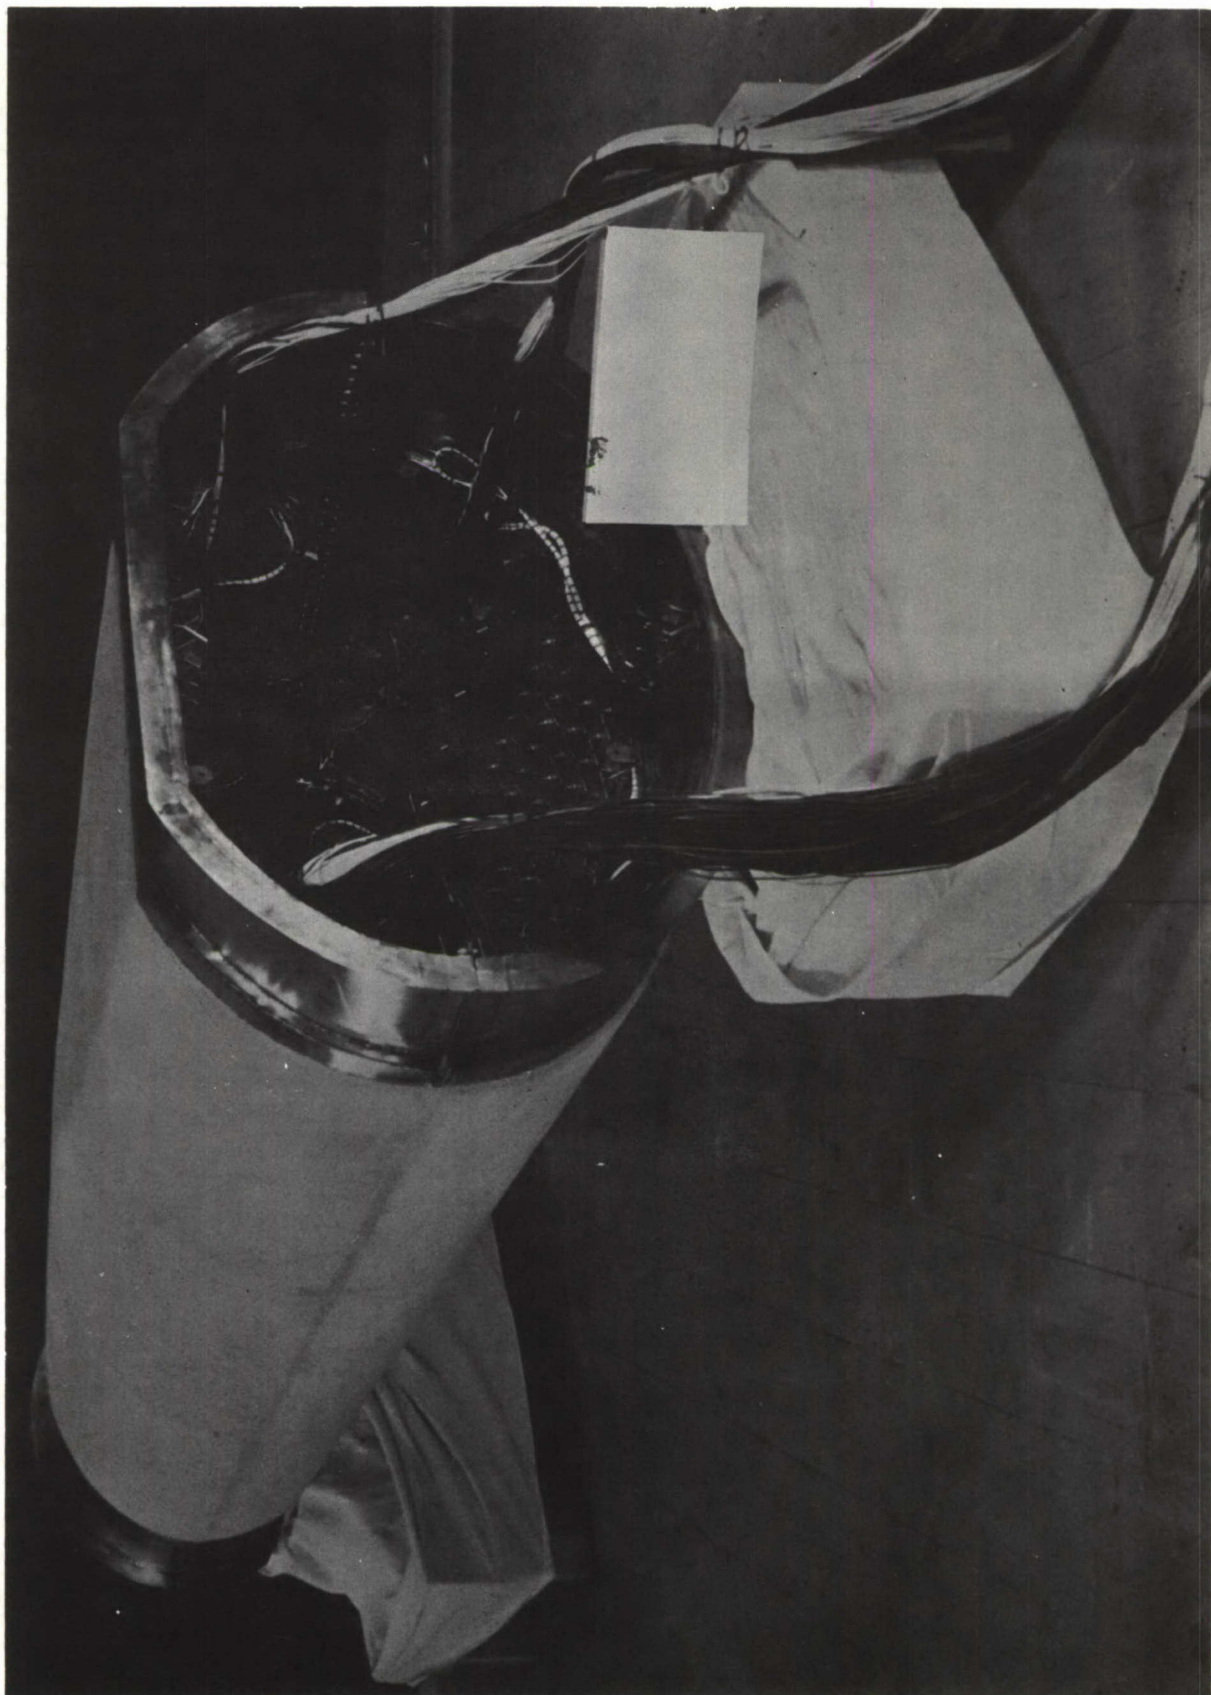
Figure 1. Thermantic Structure Test Article

The test article was a 90-inch long section based on a superorbital re-entry vehicle forebody. It was built of Aeronca's thermantic construction (see Section VII for construction details). In addition, there were metal transition sections attached to the forward and aft ends of the structure to insure that the test parameters could be properly applied and that the structure's response to these parameters would more nearly simulate the response of a re-entry prototype. The test article is shown in Figure 1.

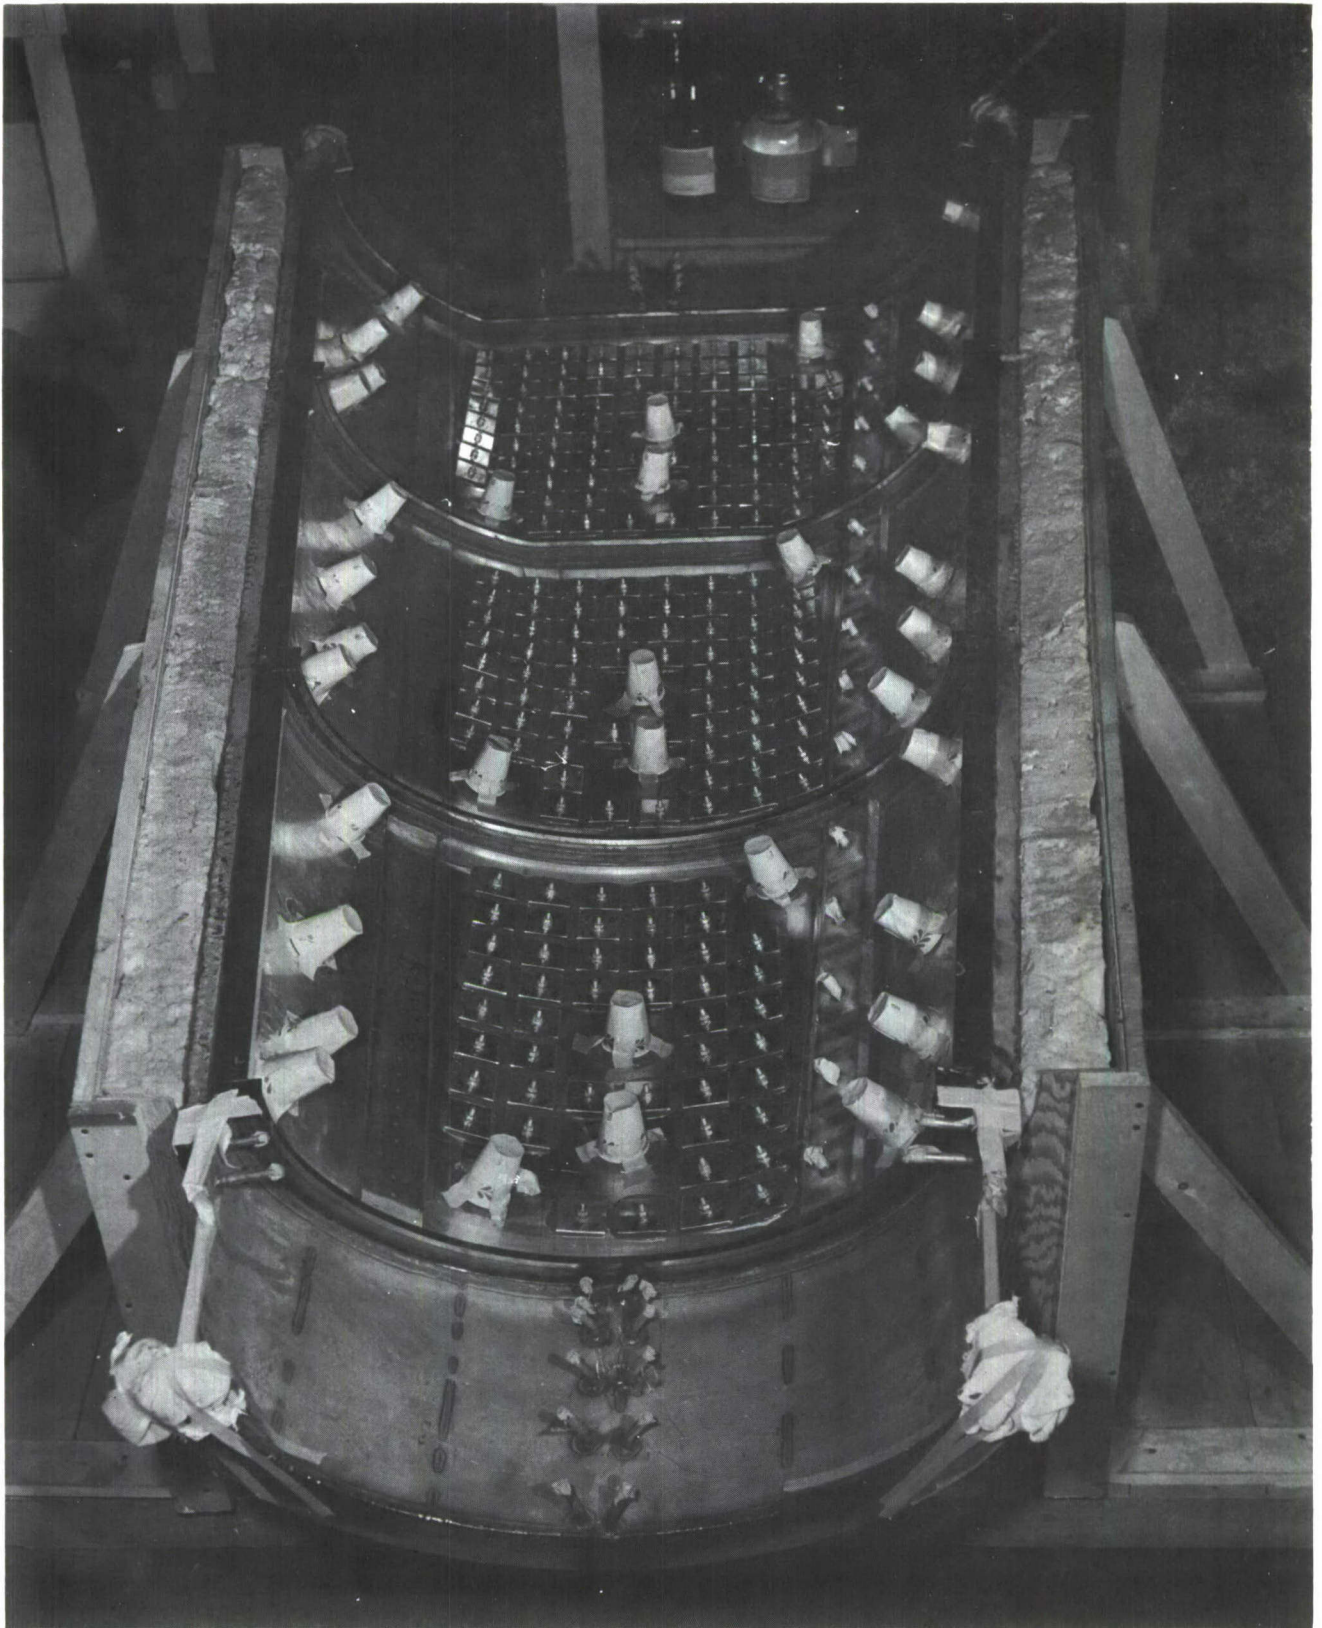
Figure 2. Tension Plate Layout

The vehicle was loaded through metal tension plates bonded to the interior of the test vehicle with General Electric RTV Silastic. Figure 2 shows the tension plate layout for the upper half of the vehicle. The layout of the lower half is similar to this. These loading points were interconnected to produce particular loading distributions by aluminum "whiffle trees." The nose cap loads were applied through straps bolted to the forward transition section. The equipment loads were applied to the equipment mounting lugs attached to each of the frames. All loads

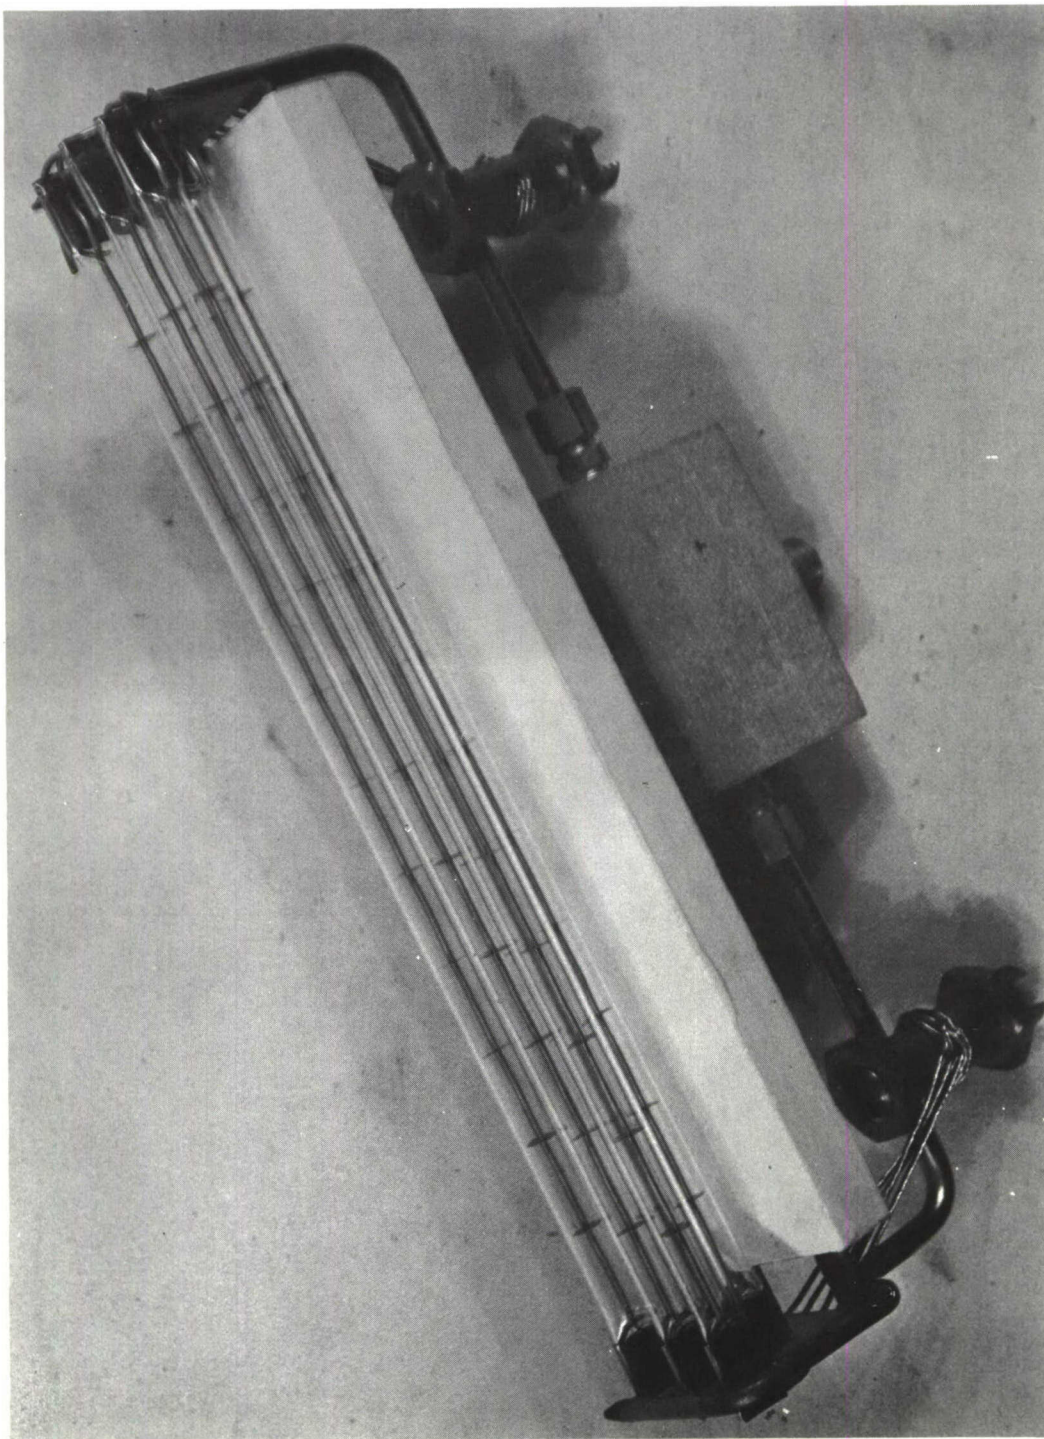
Figure 3. Pyro-Metric Infrared Heater Assembly

Items 5 and 6 were designed by Pyro-Metric, Incorporated. The reflector body was cast from a refractory oxide which has a melting temperature above 3000°F. All metal parts exposed to high temperatures were fabricated from stainless steel. Each individual reflector held five lamps. Lamp densities of 25 lamps per square foot were possible with these units. The original heater that was evaluated had a single 3/16 in. OD line to blow air down the center of the lamp array. An FDTT designed modification was then incorporated with the basic heater. This modification replaced the single air tube with seven small tubes (.039 in. ID) to direct the air jets underneath and between the lamps for more effective cooling. This arrangement reduced the volume of air required and minimized the effect of the air on the specimen. With 425 volts applied to the lamps, specimen temperatures of 3200°F were attained. This modified heater was the one selected for use on the thermantic structure.

Radiant heating techniques were utilized for the elevated temperature conditions. The basic heating elements used were General Electric 1500T3/CL infrared heating lamps. These lamps were mounted on Pyro-Metric PM 500M ceramic reflector assemblies (Figure 3). The reflector assemblies were then mounted on an air manifold and support frame which were contoured to match the shape of the test article (Figure 4).

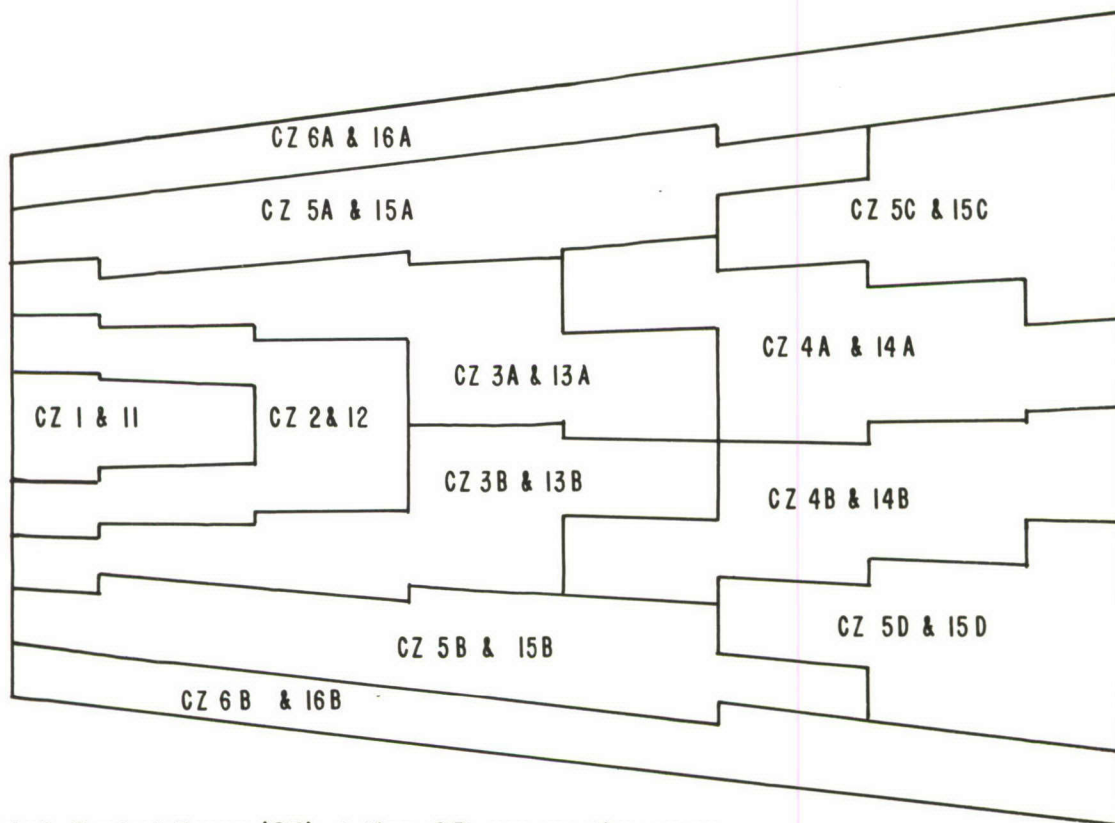
Figure 5. Control Zone Layout

The test article was divided into 24 control zones (Figure 5) with a thermocouple in each zone for temperature control and monitoring purposes. The first three elevated

Note: Control Zones (CZ) 1 thru 6B are on the upper surface and Zones 11 thru 16B are on the lower surface.

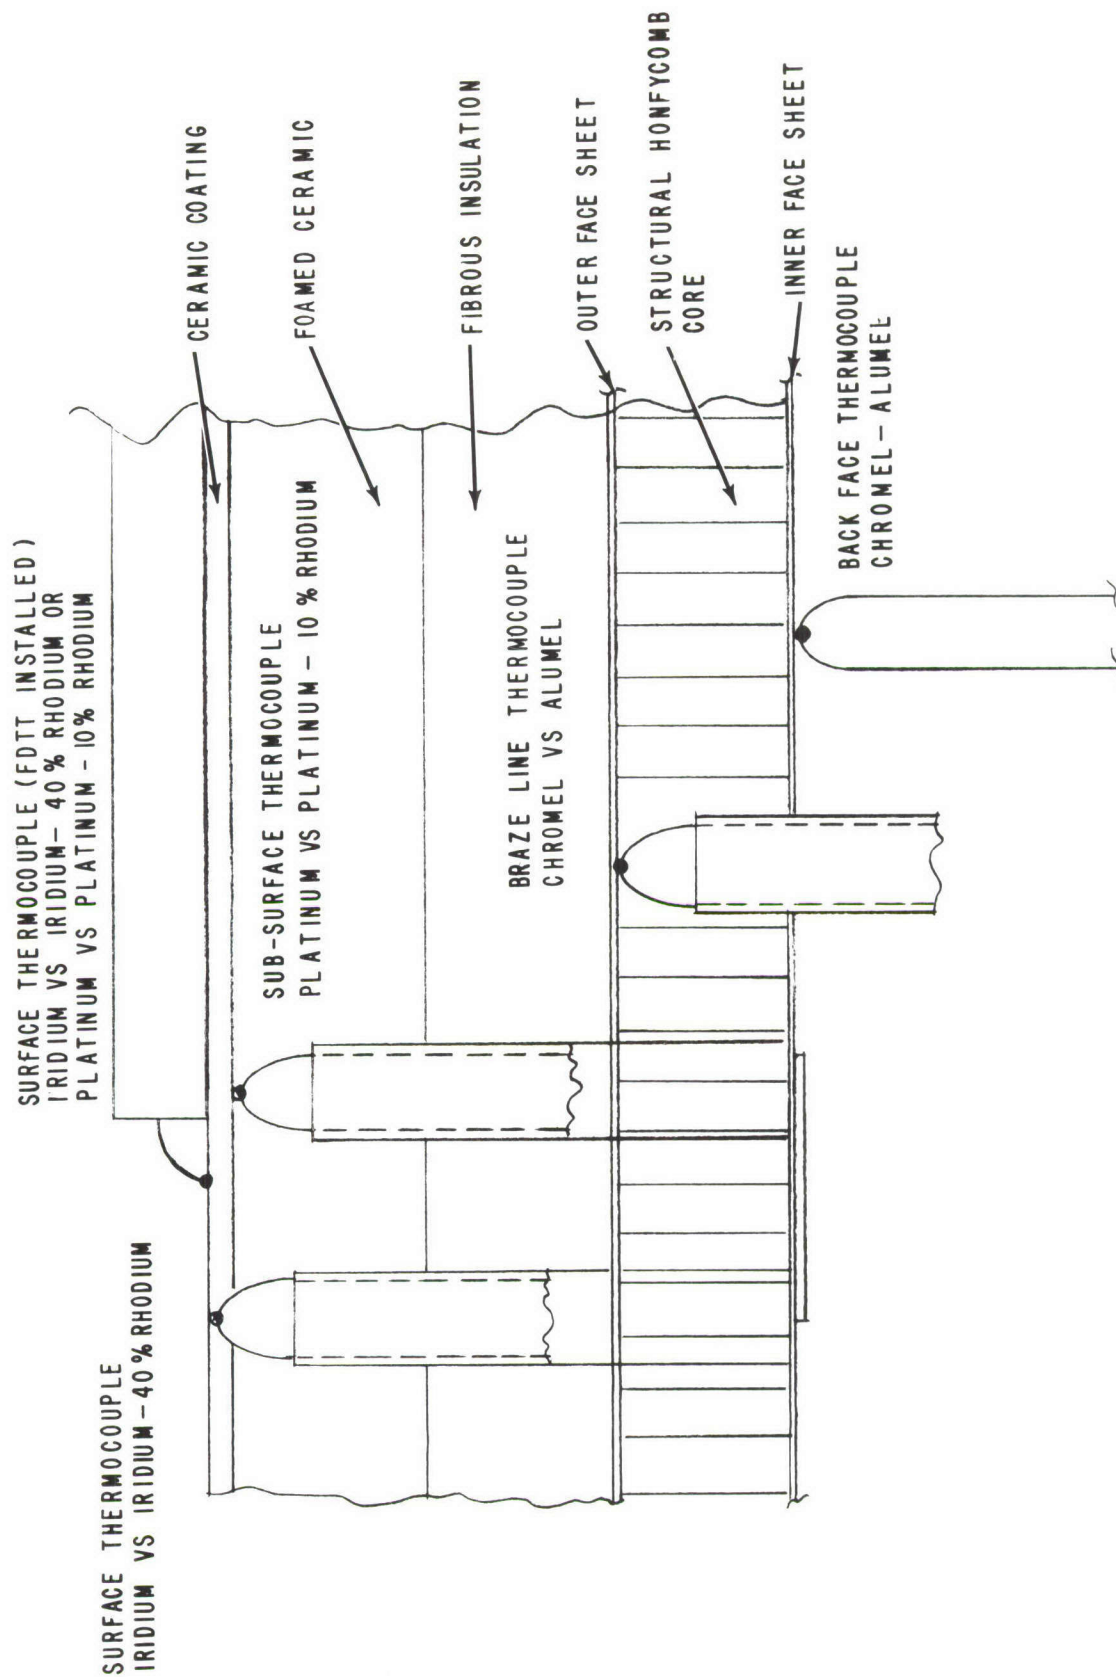
Figure 6. Thermocouple Installation

During the checkout of the infrared heating system, it was noted that the response of the contractor-installed control thermocouples was very slow. A subsequent inspection of these thermocouples showed that they were not flush with the surface as had been planned. In some cases, the junction was simply not at the surface. In other cases, the thermocouple wires were touching for some distance into the structure. This, in effect, put the measuring junction at some point below the surface. The sub-surface thermocouples were found to be in the same condition. Surface thermocouples were then installed by FDTT for temperature control (Figure 6). The originally installed thermocouples were monitored during each test, but the data was not used for the thermal analysis of the structure.

The thermocouples mounted on the surface posed a different problem. When the ceramic coating in the area of a thermocouple separated from the structure, the thermocouple was lifted from the surface and would give a false temperature indication. This problem was partially eliminated by using a thin wash coat of ceramic for the last three elevated temperature runs. The thin coating showed less cracking and better adhesion than the original thick coating.

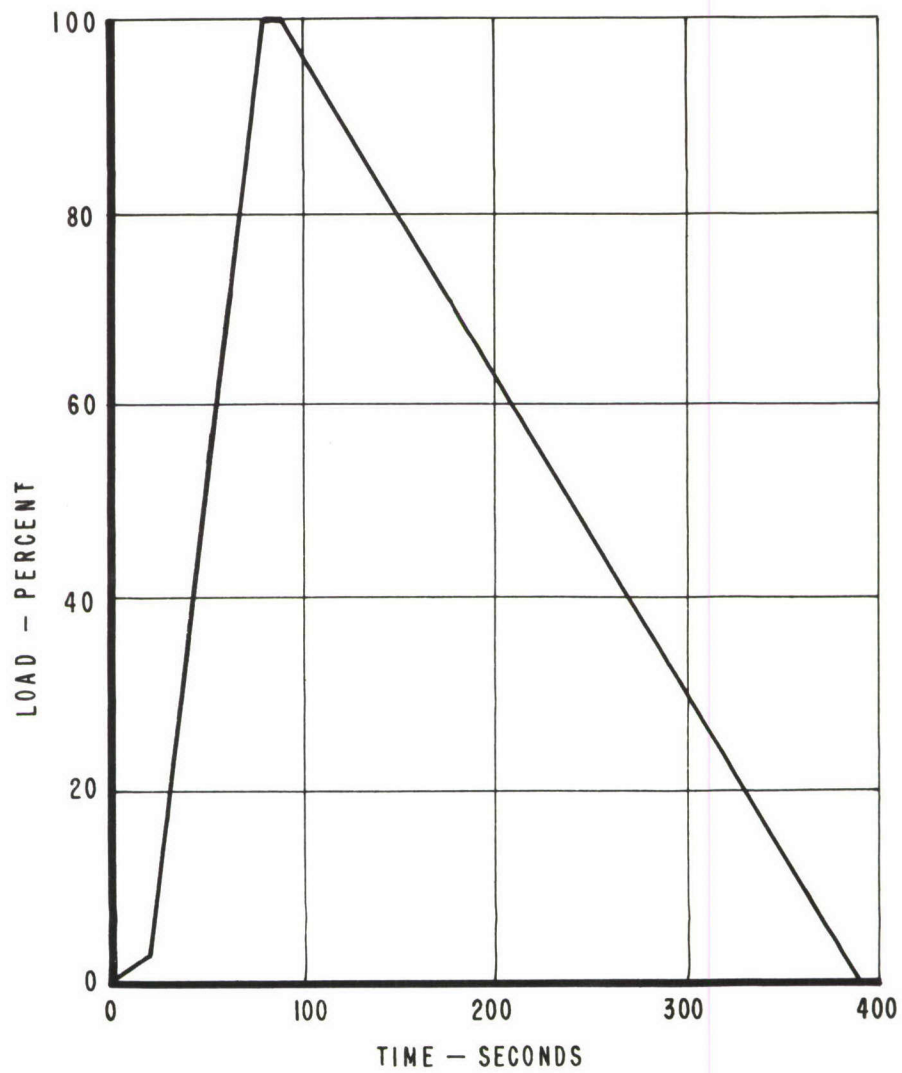
Figure 7. Time-Load Program

Static Test I was a room temperature, load only condition. The loads were those loads associated with the +10 g point of the first re-entry cycle (Reference 2, Page 21). The loads were controlled automatically by the 50-Channel Controlled Loading System. The loads followed the time-load program shown in Figure 7. All data was read and recorded at a rate of one sample per second for the first 105 seconds of the load program. There was no damage to the structure from this test.

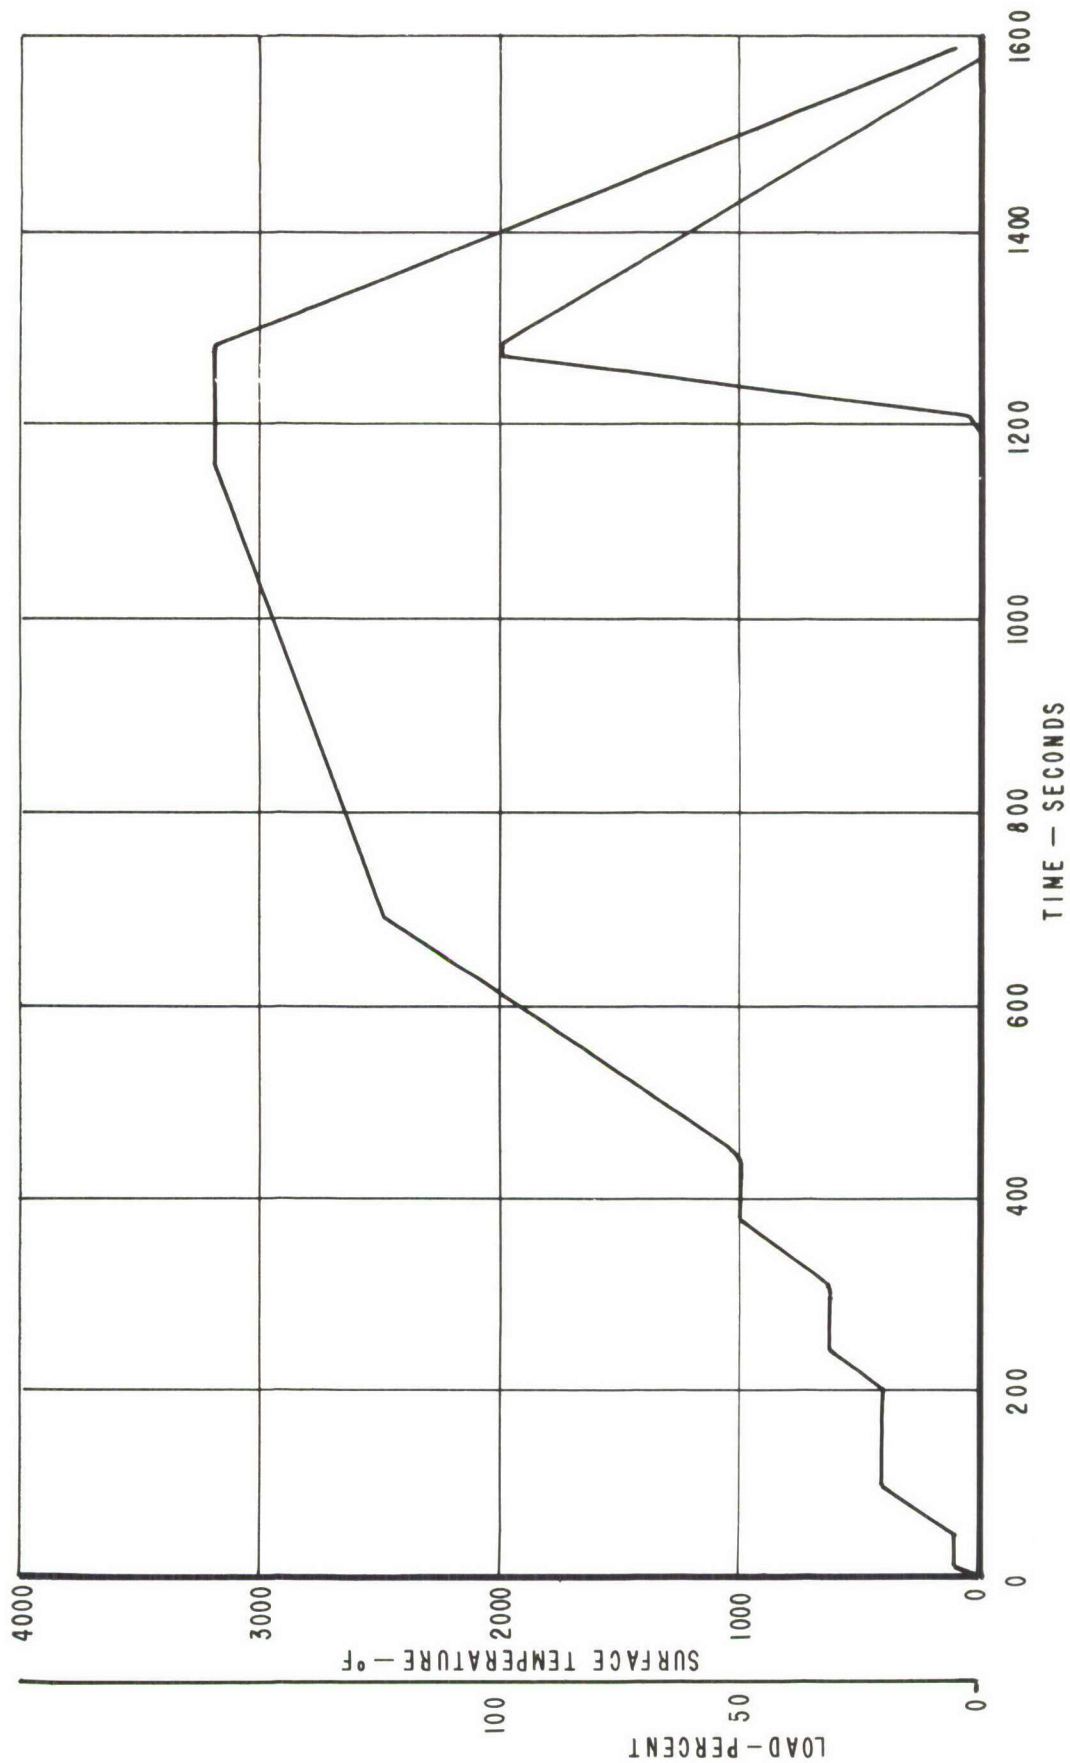
Figure 8. Temperature and Load vs Time

(HCC No. 2) for temperature control. The computer was programmed to follow the time-temperature curve shown in Figure 8. The program was held on the 400° and 1000°F plateaus to check the operation of HCC No. 2. The test was stopped when pieces of the ceramic coating fell into the lamps and caused several lamp failures. The surface temperatures recorded just prior to the end of the test ranged from 2500° to 2800°F.

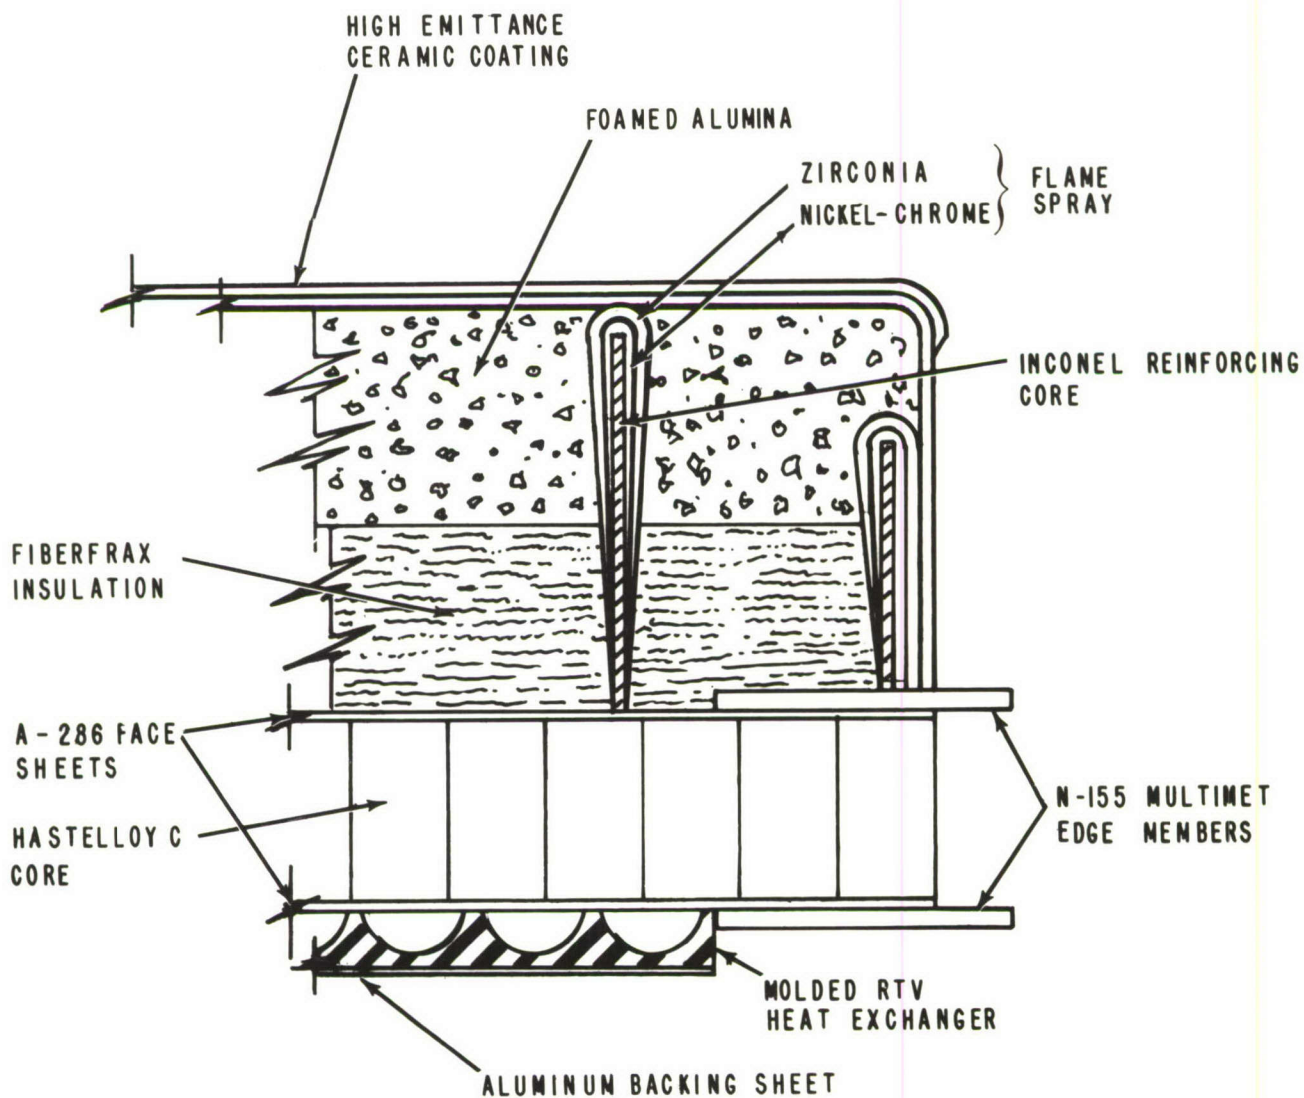
Figure 9. Thermantic Construction

The primary structure consisted of load bearing honeycomb sandwich panels welded and/or mechanically joined together. The panels used A-286 for the face sheets and Hastelloy C for the core. Edge members of N-155 were brazed to the panel face sheets to provide suitable material for welding at the longitudinal and transverse joints. The structure was stabilized by conventional ring frames located at Stations 35, 65, 95, and 125. The rings and webs were machined in two halves, upper and lower, from N-155 multimet plate.

The primary structure was protected from the environmental heat flux by a ceramic heat shield. The heat shield was reinforced by an open face Inconel honeycomb core. This core was brazed to the outer face of the structural panels at the same time as the panel brazement was made. The reinforcing core was flame sprayed to provide oxidation protection to the core and to assist in the adhesion of the foamed ceramic material. There were two coats applied, one nickel-chrome undercoat and a final coat of zirconia flame spray. Fiberfrax fibrous insulation was installed to a depth of .50-inch into the bottom of the reinforcing core. The use of the fibrous insulation improves the structures insulation characteristics and reduces the total weight. Foamed alumina was then added to finish filling the honeycomb core. The alumina foam was the primary heat rejection component of the heat shield. The alumina reradiated a high percentage of the incident heat flux and its low thermal conductivity minimized the heat transfer through the structure. The heat shield was completed with the application of a zirconia base, high emittance coating. This final coating was used to increase the thermal capability through higher emittance, protect the heat shield reinforcing honeycomb core, provide increased erosion resistance, and to maintain an aerodynamic surface. A molded RTV rubber heat exchanger was bonded to the back face of the structural honeycomb. Water

was circulated through the heat exchanger to maintain a back face temperature of 100°F.

Details of the structure are shown in Figure 9. A discussion of the design, fabrication, and properties of the thermantic structure is contained in References 2 and 3.
